# U-values & Retrofitting Traditionally Built Walls

Coleman Court  
25<sup>th</sup> March 2014

Caroline Rye

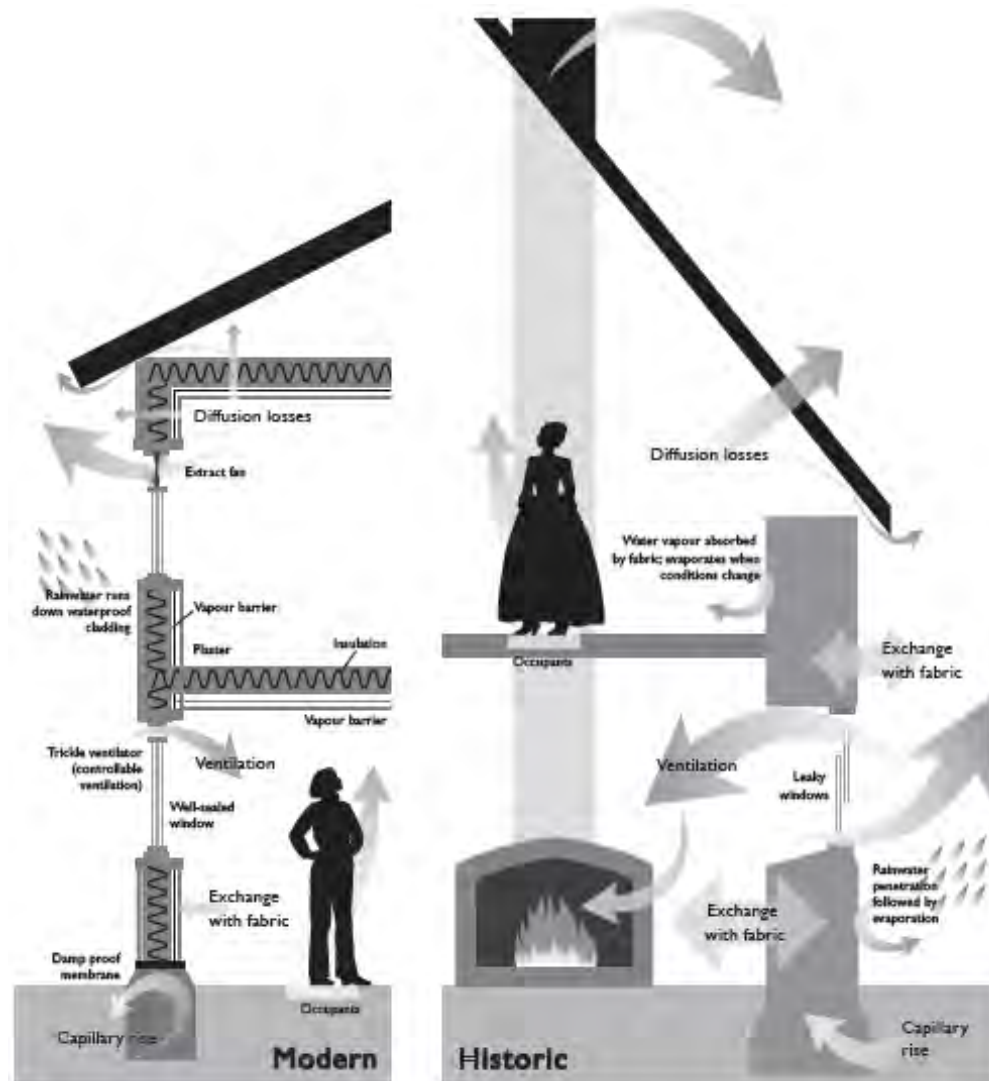
# Moisture Management Ventilation (and heat) for Evaporation

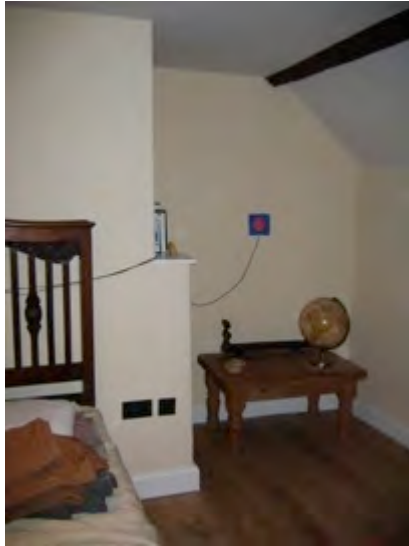
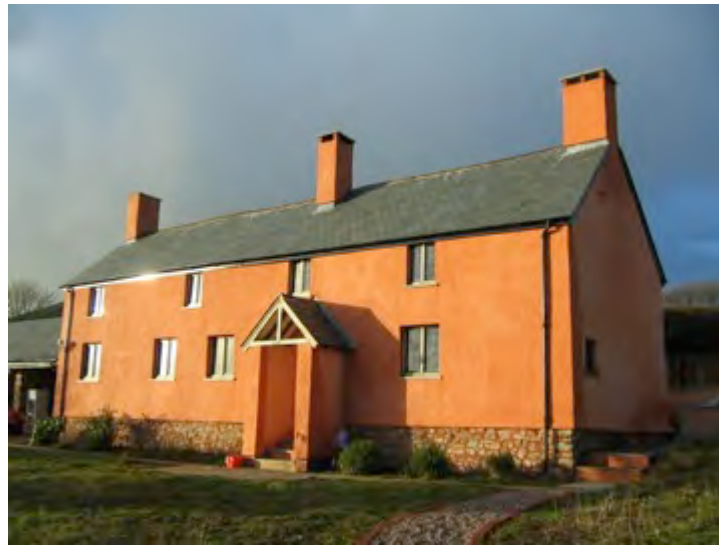
## *In situ*/Calculated U-value comparison

### Wall build up

Lime Plaster	15
Granite	400
Cement render	13
Lime roughcast render	25
Overall	453mm

*In situ* U-value 1.75 W/m<sup>2</sup>K

RdSAP U-value 2.3 W/m<sup>2</sup>K

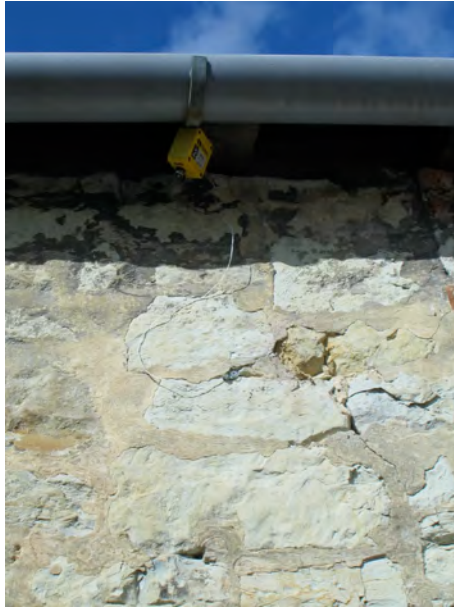
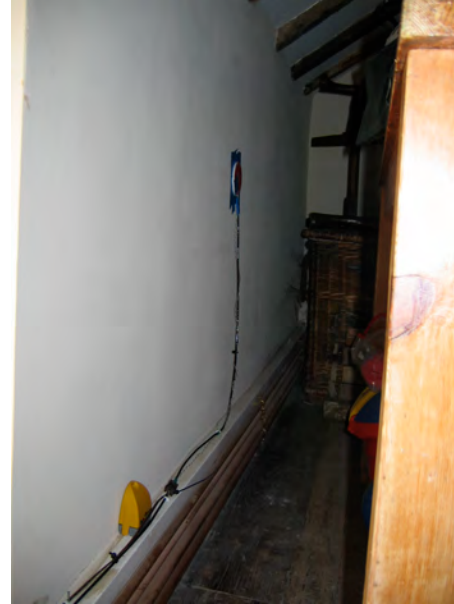
## *In situ*/Calculated U-value comparison

### Wall build up

Gypsum plaster	15
<u>Malmstone</u>	<u>310</u>
Overall	325mm

In-situ U-value 1.34 W/m<sup>2</sup>K

*RdSAP U-value 2.0 W/m<sup>2</sup>K*

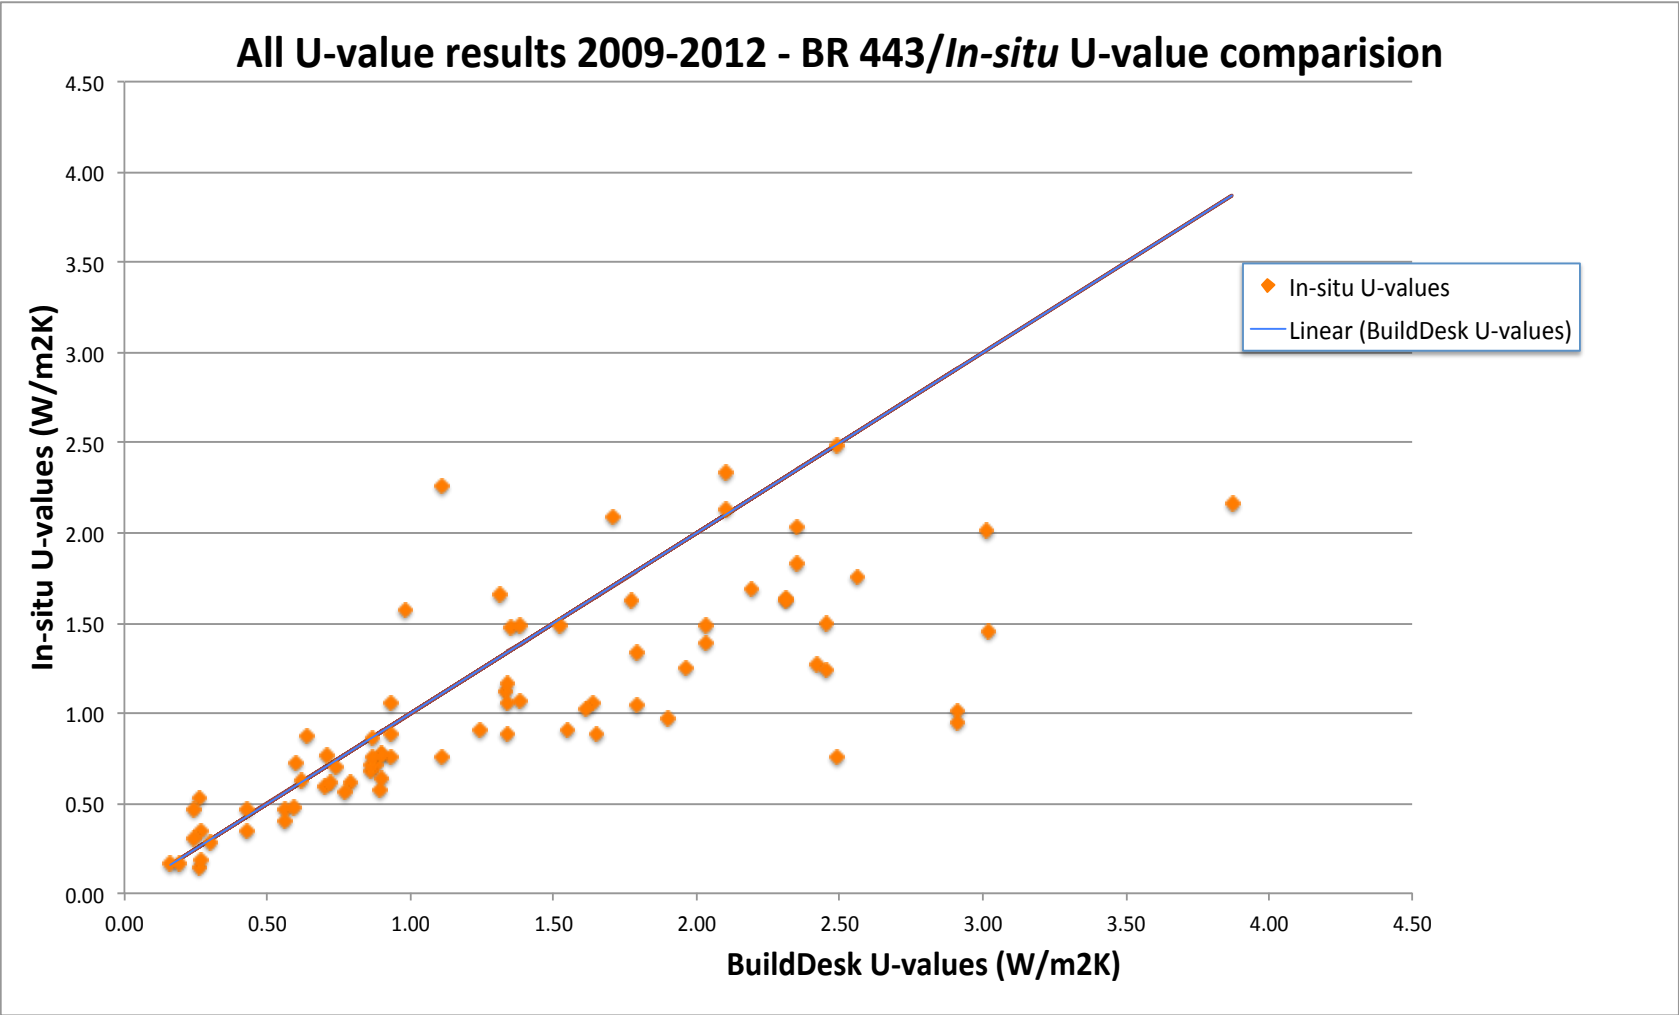
# Measured in situ and calculated U-value comparison SPAB U-value Research

Calculation overestimates U-value in 77% of cases

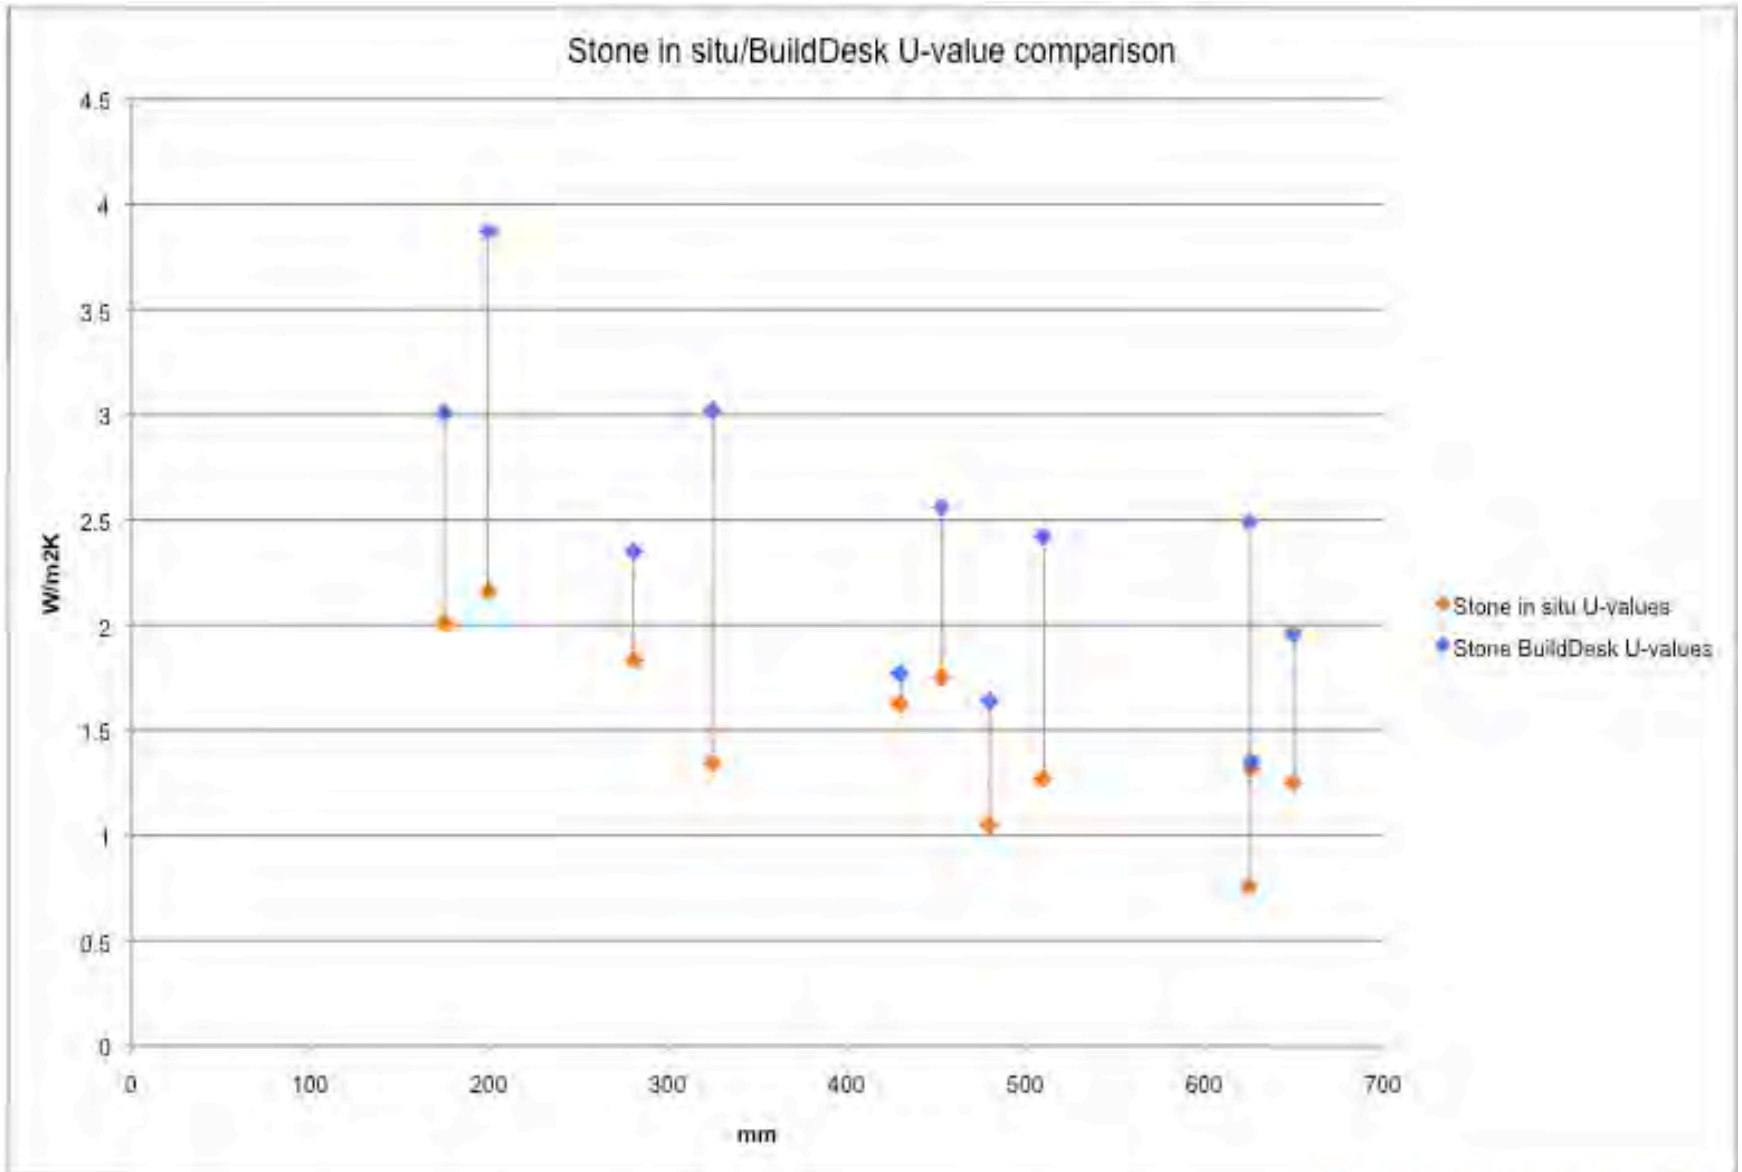
# Uncertainty in U-value Calculations – Stone Walls

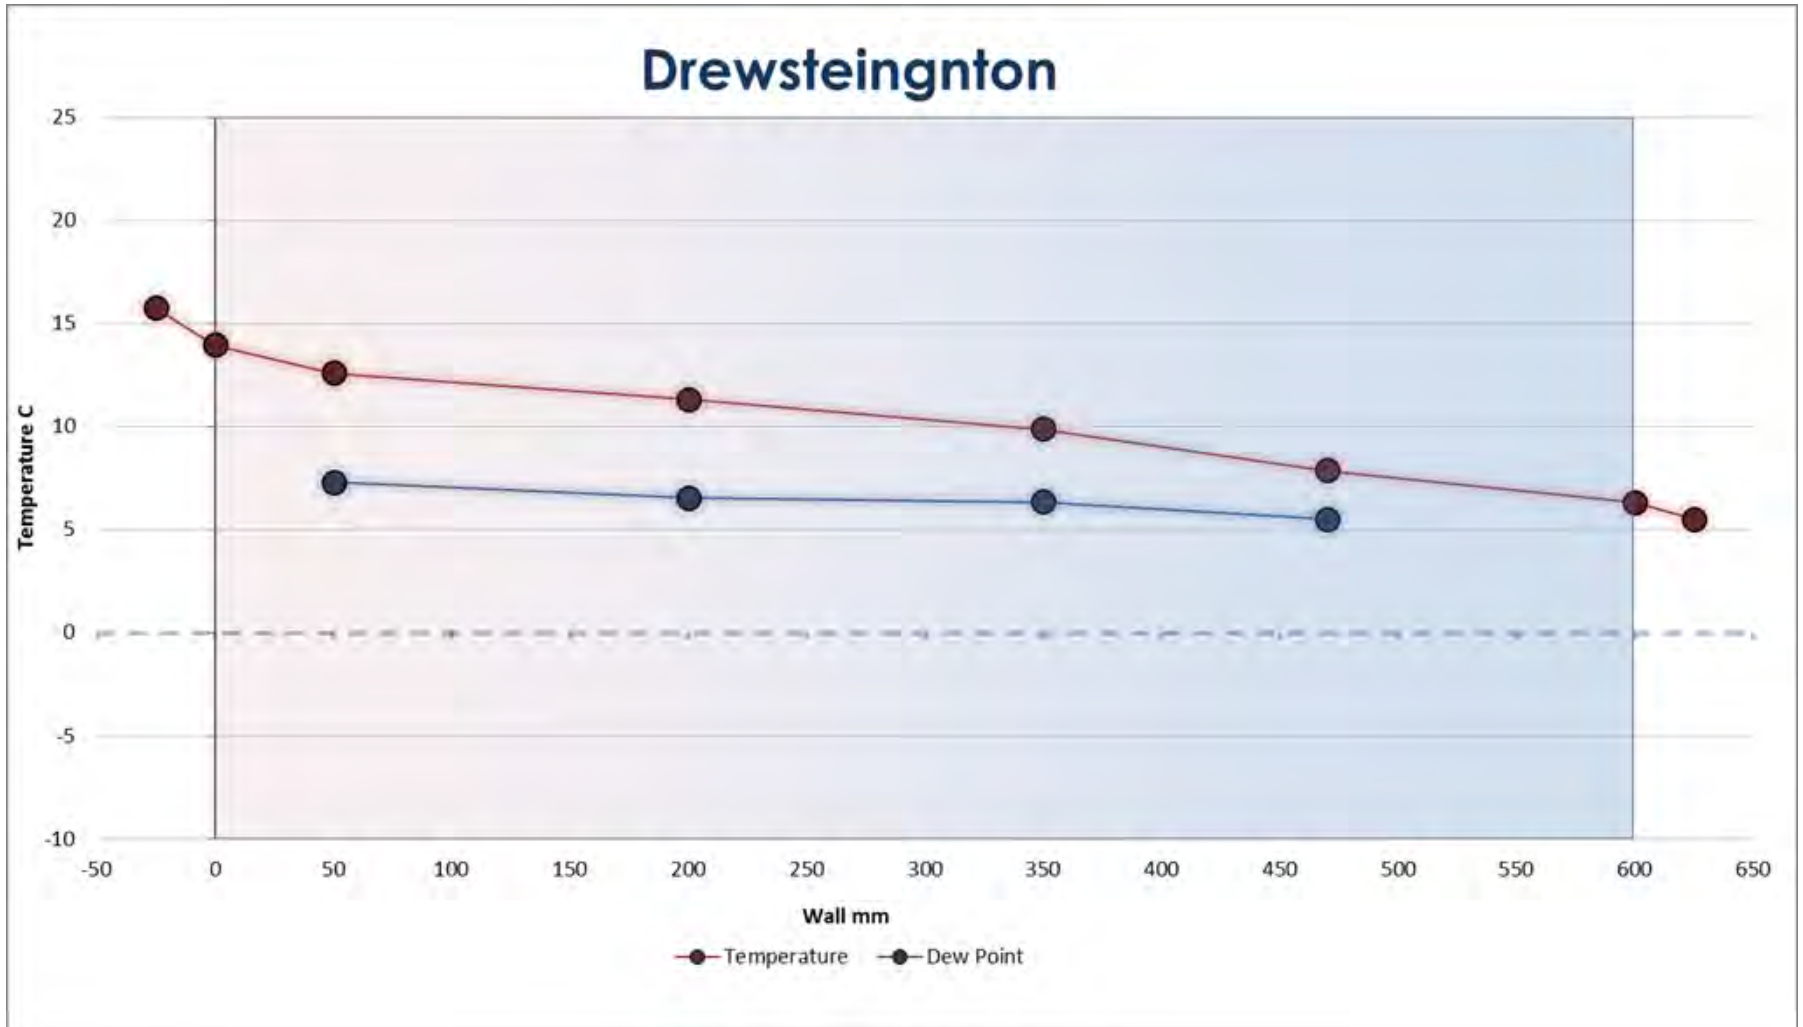
# Granite Wall – Hygrothermal Wall section - Uninsulated

Uninsulated in situ U-value = 1.24 W/m<sup>2</sup>K

Dewpoint margin – all 4 nodes = 4.01°C, outer node = 2.98°C

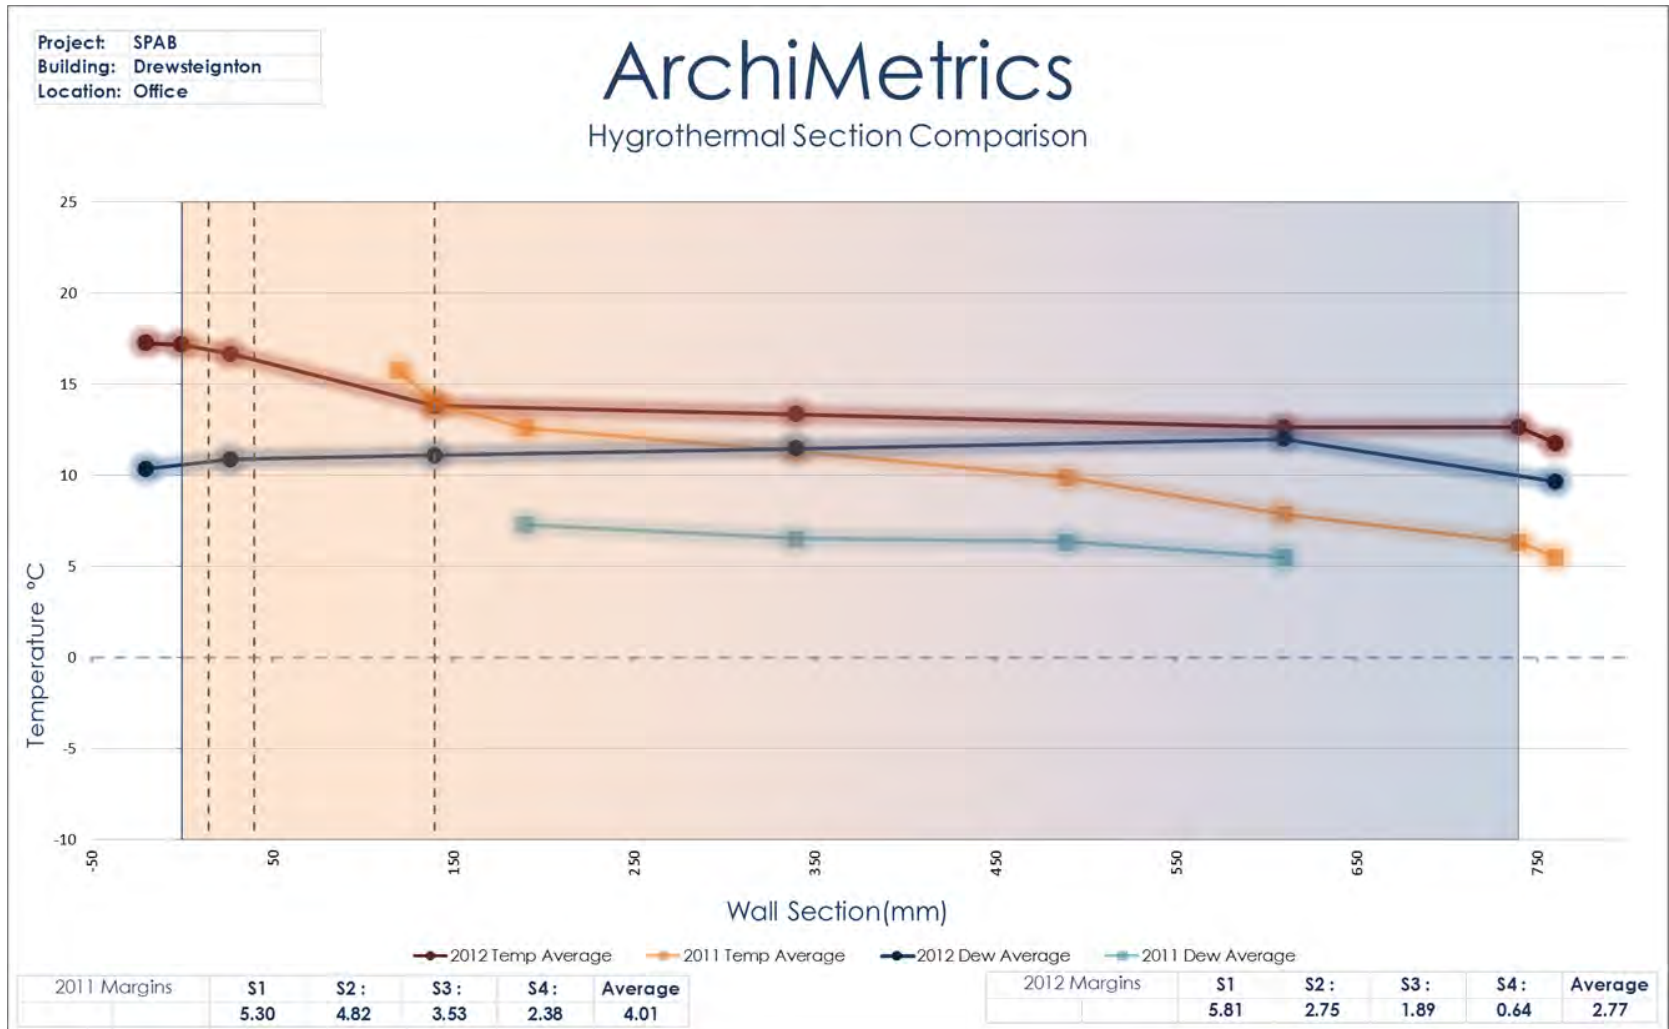
# Granite Wall – Hygrothermal Wall section - Insulated

Insulated (100mm PIR) in situ U-value = 0.16 W/m<sup>2</sup>K

Dewpoint margin – all 4 nodes = 2.77°C, outer node = 0.64°C, 76% reduction

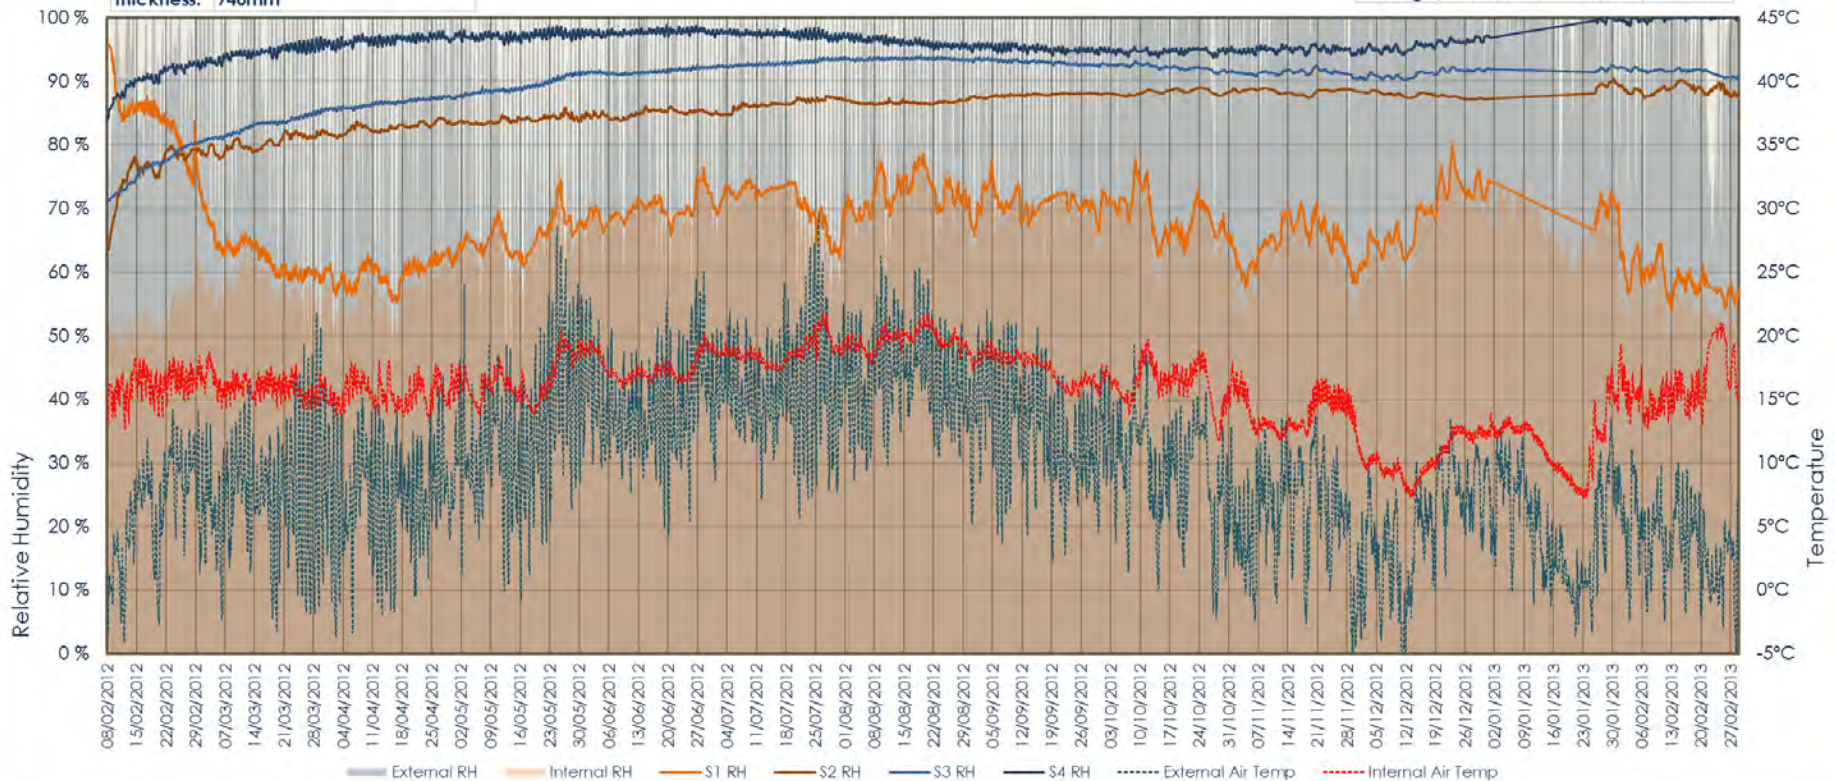
Project:	SPAB BPS
Building:	Drewsteignton
Location:	Office
Start:	08/02/2012
End:	28/02/2013
Logger:	AMIG/06
Material:	Granite & PIR IWI
Thickness:	740mm

## Relative Humidity Over Time

RH %	Minimum	Maximum	Average
Internal	45.08	86.13	64.57
S1	53.72	95.73	67.83
S2	63.24	90.38	85.45
S3	71.14	94.06	89.74
S4	84.09	100.00	96.01
External	28.54	100.00	92.31
Average	57.63	94.38	82.65

IWI - Drewsteignton - Granite Wall 600mm thick insulated with 100mm PIR – foil-faced, taped joints, air gap, plasterboard & skim
