DECC Solid Wall Research Project

Colin King
25th March 2014

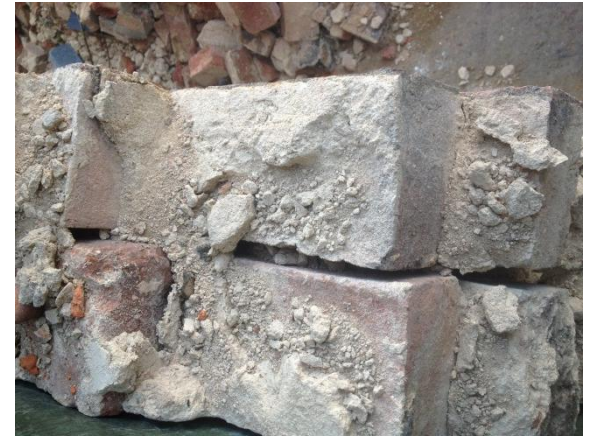
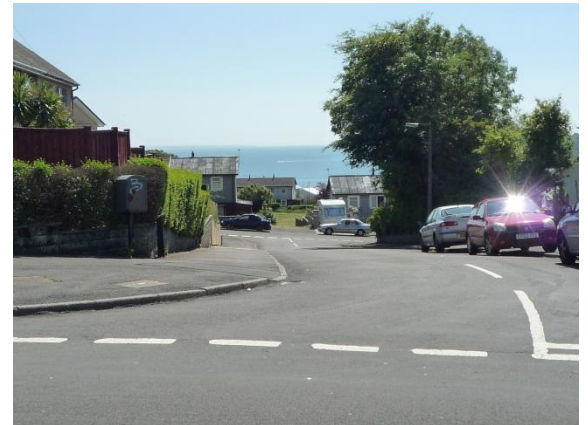
Work Package 2 - Understanding heat losses from solid walls

- Moisture content
- Micro cavities
- Continuity of mortar
- Unknown properties of materials within structures
- Thermal conductivity of different materials
- Effects of Exposure and Rh on u-values
- Hot boxing and in situ measurement of a range of configurations

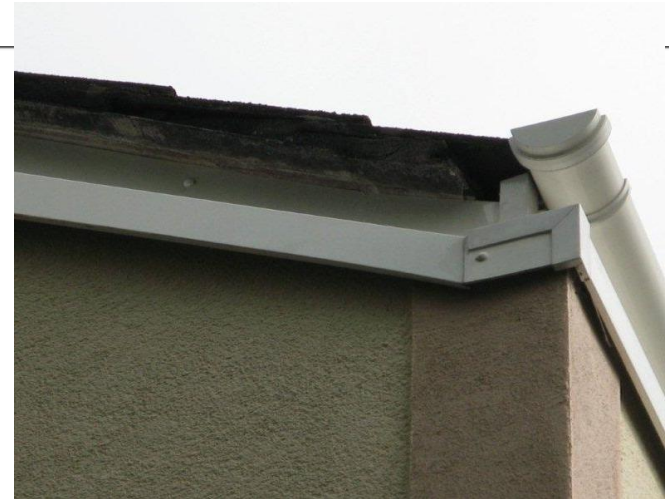
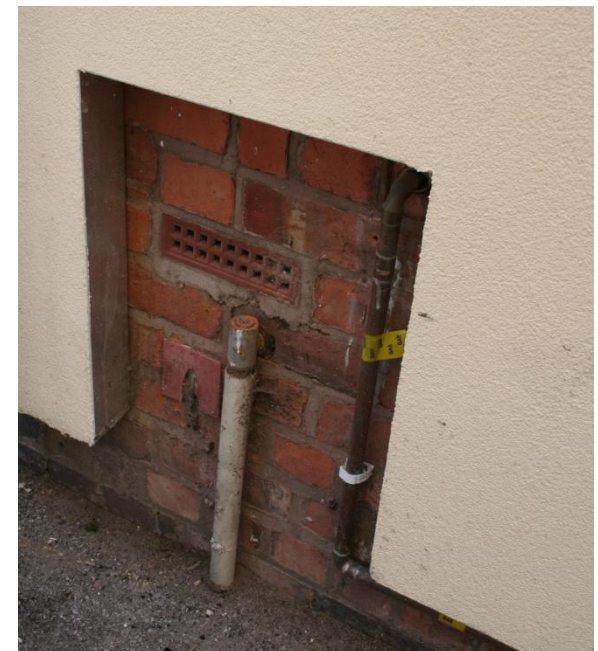
WP 5 -Revisiting previous work

- Previous experience of the effect of inappropriate insulation.
- Previous experience of poorly assessed buildings being chosen for insulation
- Poor detailing on site – even if appropriate
- Understanding of the risk of insulating older properties, with many unknown factors being assumed.
- Understanding the effect of wind driven rain on buildings

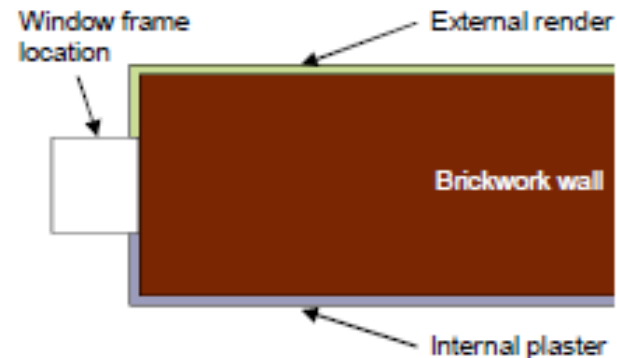
Figure 1a: Baseline jamb detail

- Standard Industry approach to detailing openings
- Difficult to insulate ? so rarely done.
- Impact of in-correct detailing

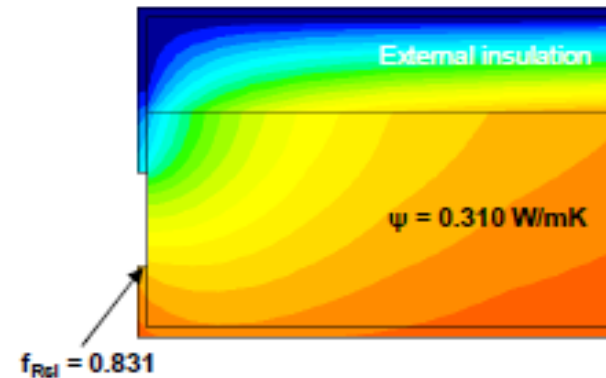
c: Jamb with 'typical' external insulation

- Initial modelling indicates if the reveals and heads etc are not insulated the psi value of the area becomes worse than before insulated.
- Risk shifted to areas least capable of dealing with them.
- Increased heat loss, and much higher risk of condensation and mould growth / failure.
