Insulating Solid Walls: Findings from pre and post refurbishment performance monitoring from the SPAB Building Performance Survey

Coleman Court 25th March 2014

Caroline Rye

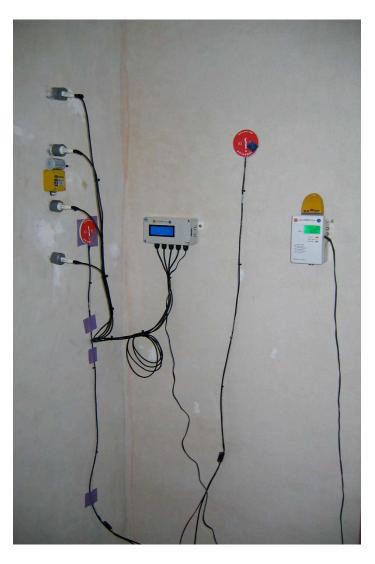
- Fabric heat loss through the Uvalue measurement of wall elements both in the form of in situ and calculated U-values.
- Air infiltration through air permeability testing and thermographic survey.
- Indoor air conditions and comfort levels via the measurement of CO₂, interior temperature and relative humidity.
- Moisture; room and wall moisture including wall surface and interstitial moisture behaviour.

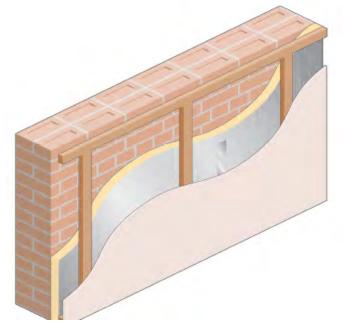
Real Retrofits - Granite Wall - IWI

IWI - Drewsteignton - Granite Wall 600mm thick insulated with 100mm PIR following manufacturers guidelines — P/B - Air gap-Foil-faced, PIR taped joints,

U-value - Granite	Uninsulated	Insulated	% Reduction
Measured	1.20 W/m ² K	0.16 W/m ² K	87%
Calculated	2.45 W/m ² K	0.19 W/m ² K	92%
Targets	SAP = 2.3	Part L = 0.30	87%

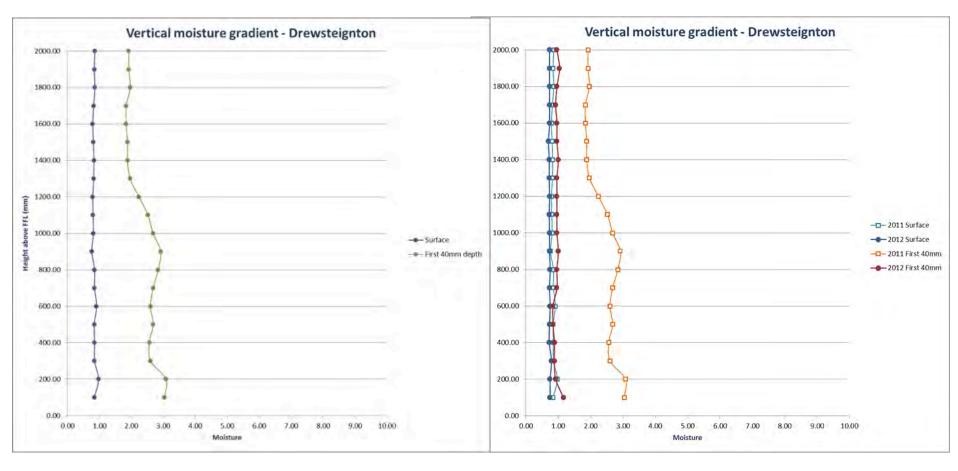
Surface & Sub surface Moisture

Uninsulated Insulated

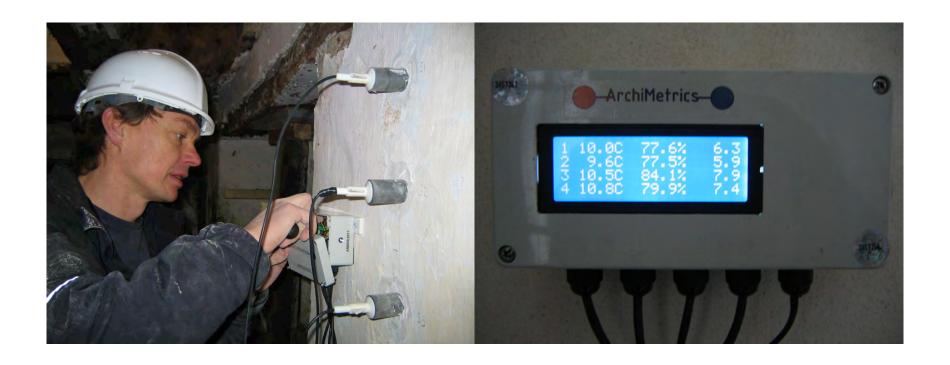
Interstitial moisture monitoring

Temperature and humidity sensing at four points through wall profile

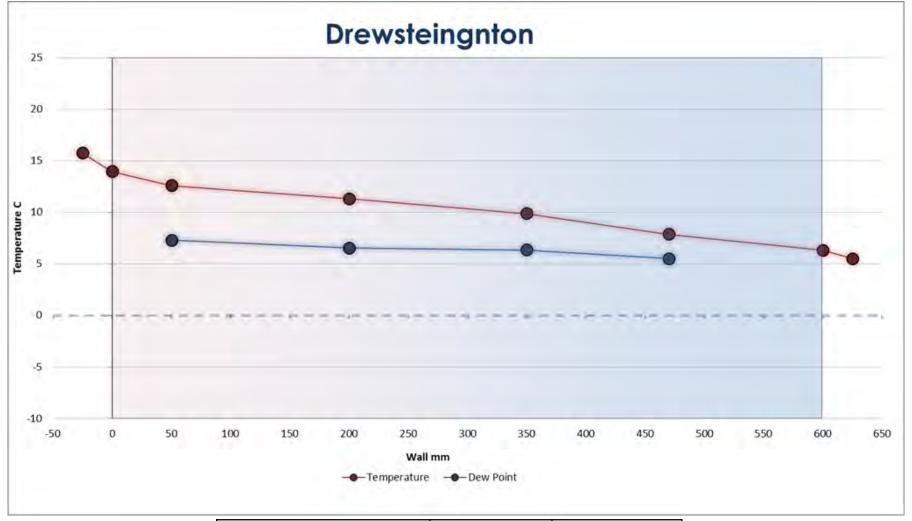
Granite – Hygrothermal Wall section - Static Average Pre-insulation

Dewpoint Margins	Average	4 th Node
Uninsulated	4.01°C	2.98°C

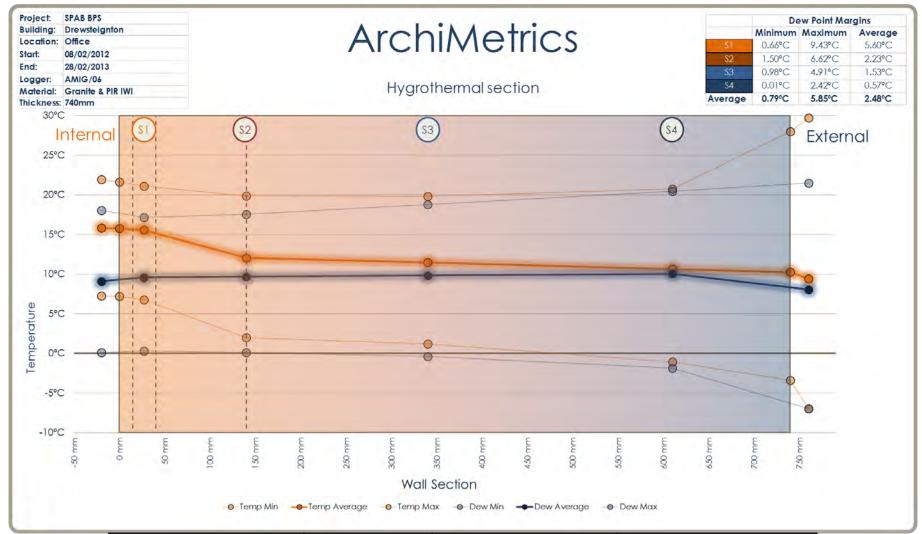
Dewpoint Margins	Feb 2011	Feb - Sept 2012	Feb 2012 - Feb 2013
Average	4.01°C	2.77°C	2.48°C
4 th Node	2.98°C	0.64°C	0.57°C

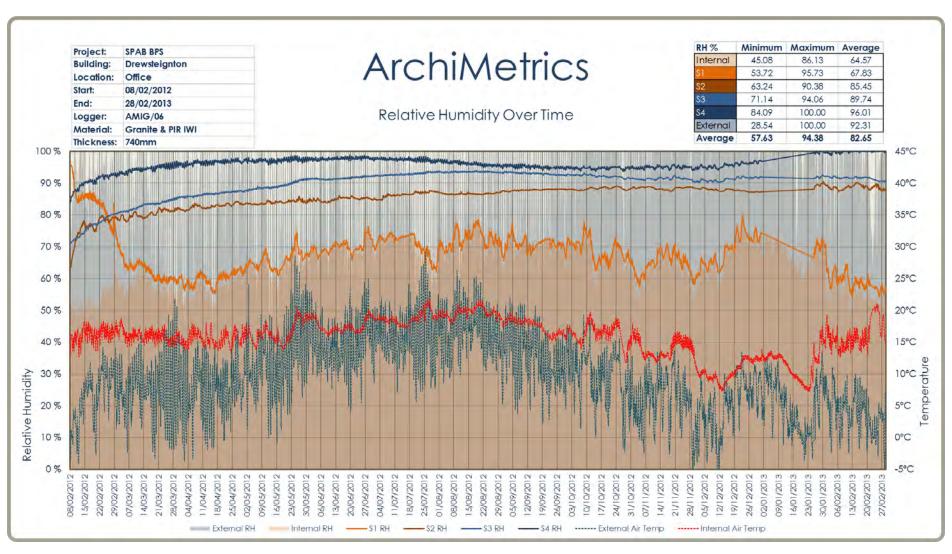
IWI - Drewsteignton - Granite Wall 600mm thick insulated with 100mm PIR – foil-faced, taped joints, air gap, plasterboard & skim

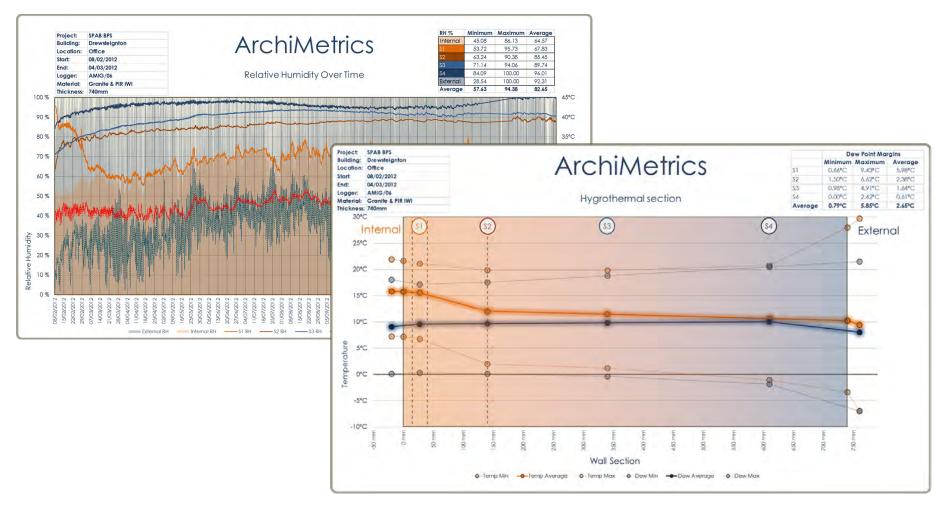
Dewpoint Margins	Average	4 th Node	In situ U-value	% reduction
Uninsulated	4.01°C	2.38°C	1.20 W/m ² K	070/
Insulated	2.48°C	0.57°C	0.16 W/m ² K	87%

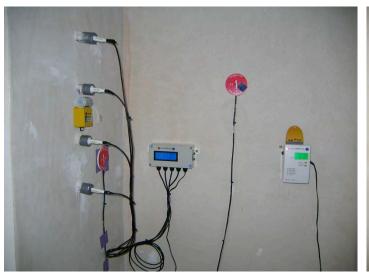
Real Retrofits – Brick Wall - IWI

Thickness not 220mm but 345mm - a brick and a half - Insulated with 40mm woodfibre – 8mm lime plaster - without a VCL

U-value - Brick	Uninsulated	Insulated	% Reduction
Measured	1.48 W/m²K	0.48 W/m ² K	68%
Calculated	1.52 W/m ² K	0.52 W/m ² K	66%
Targets	SAP = 2.1	Part L = 0.30	86%

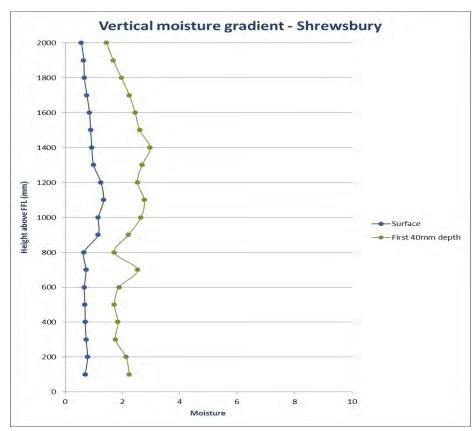
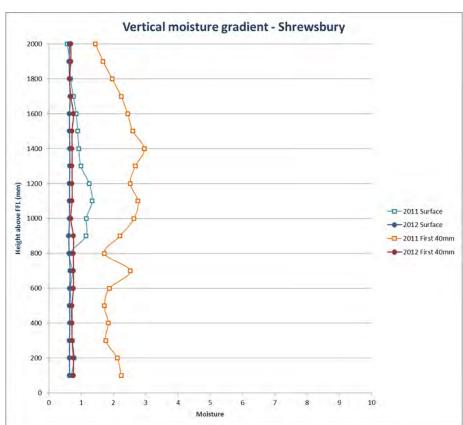
Surface & Sub-surface Moisture

2011 Uninsulated

2012 Insulated

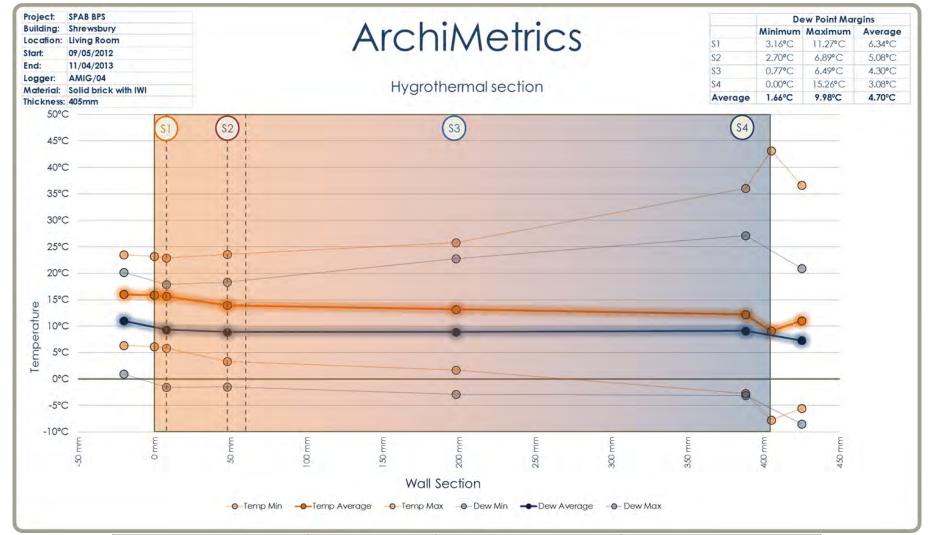
Dewpoint Margins	Feb 2011	Feb - April 2012	May '12 – April '13
Average	5.49°C	3.18°C	4.70°C
4 th Node	3.96°C	4.37°C	3.08°C

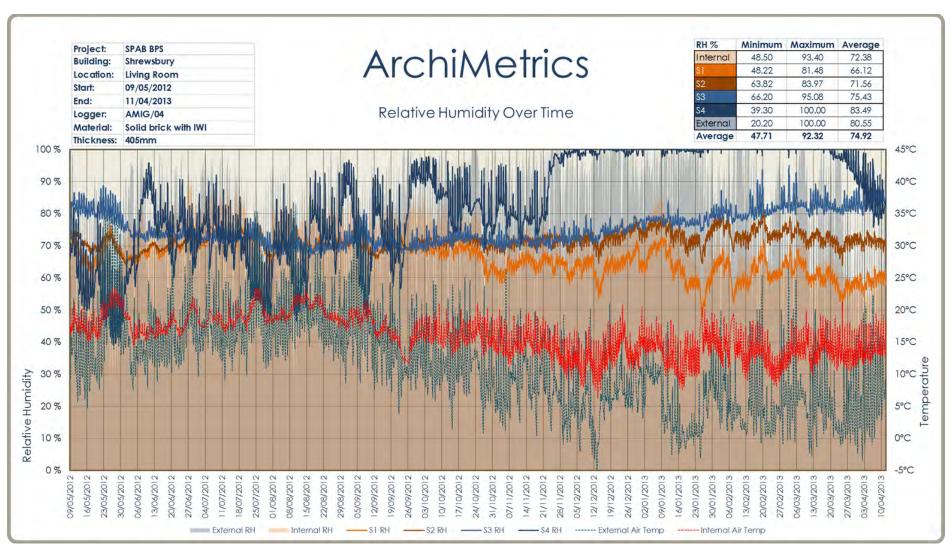
IWI – Shrewsbury - Brick Wall 345 mm thick insulated with 40 mm woodfibre – 8mm lime plaster – no vcl

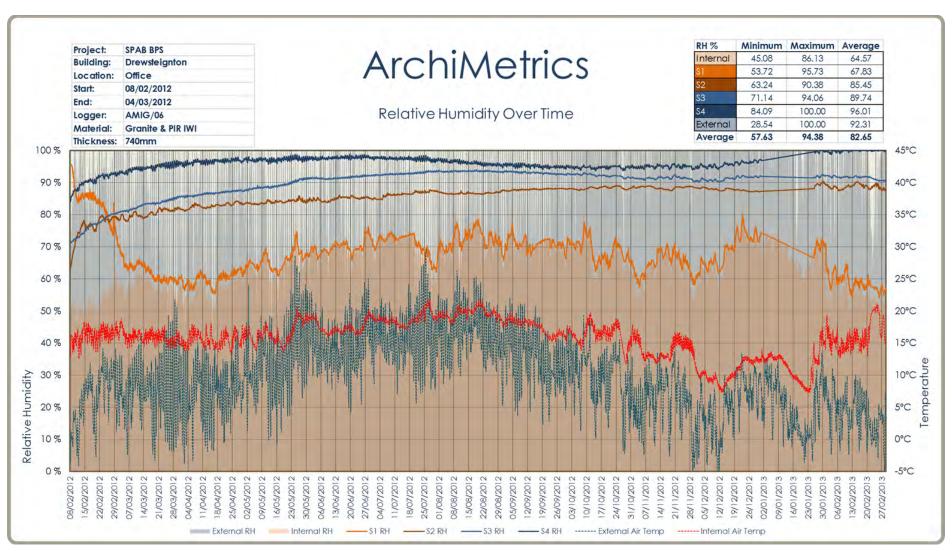
IWI - Drewsteignton - Granite Wall 600mm thick insulated with 100mm PIR following manufacturers guidelines – P/B - Air gap-Foil-faced, PIR taped joints,

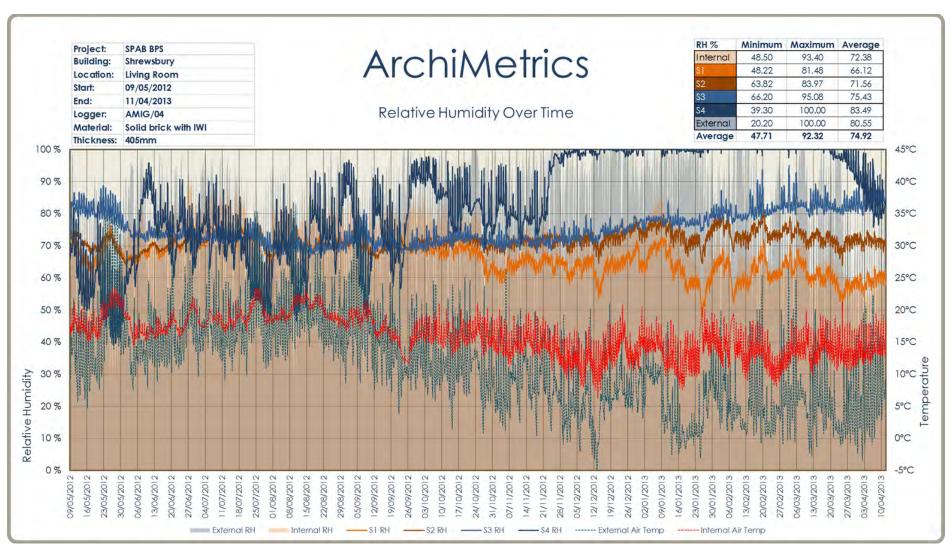
IWI – Shrewsbury - Brick Wall 345 mm thick insulated with 40 mm woodfibre – 8mm lime plaster – no vcl

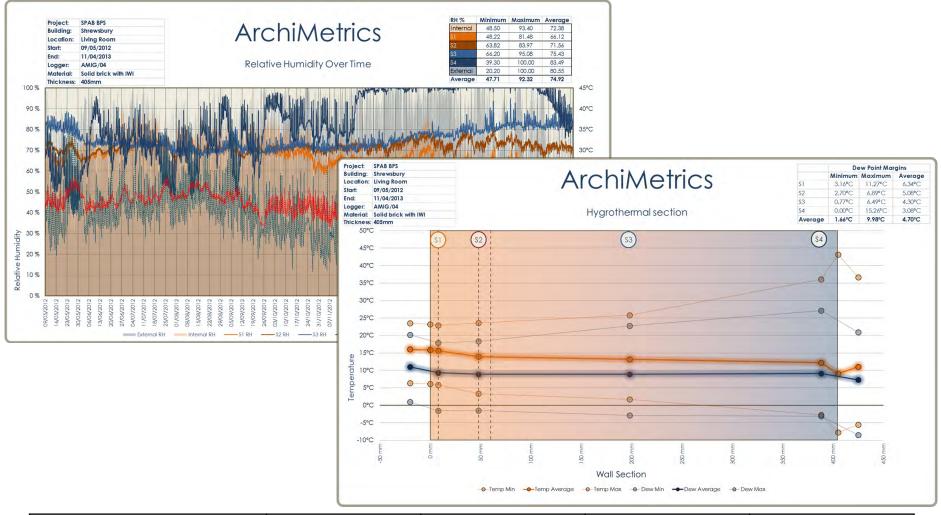
Dewpoint Margins	Average	4 th Node	In situ U-value	% reduction
Uninsulated	5.49°C	4.70°C	1.48 W/m ² K	C90/
Insulated	3.96°C	3.08°C	0.48 W/m ² K	68%

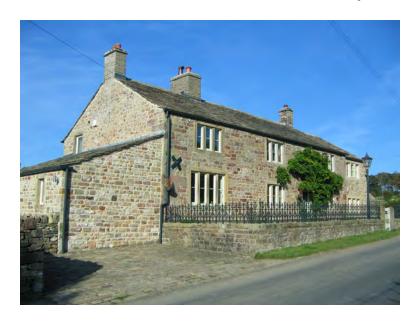
Skipton – U-values

IWI – Skipton – Sandstone wall 540 mm thick insulated with 35 mm Hemp/lime plaster and finished with 5mm lime plaster = 580 mm OA

U-value - Sandstone	Uninsulated	Insulated	% Reduction
Measured	1.63 W/m ² K	1.00 W/m ² K	38%
Calculated	2.31 W/m ² K	1.17 W/m ² K	49%
Targets	SAP 2.0 W/m ² K	0.3 W/m ² K	85%

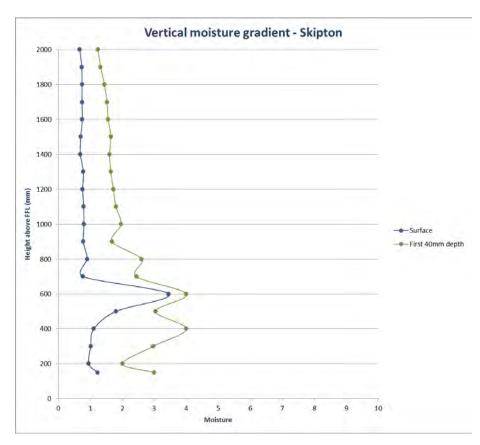
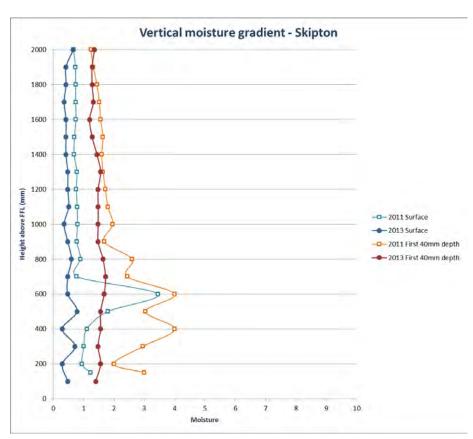
Surface & Sub-surface Moisture

2011 Uninsulated

2013 Insulated

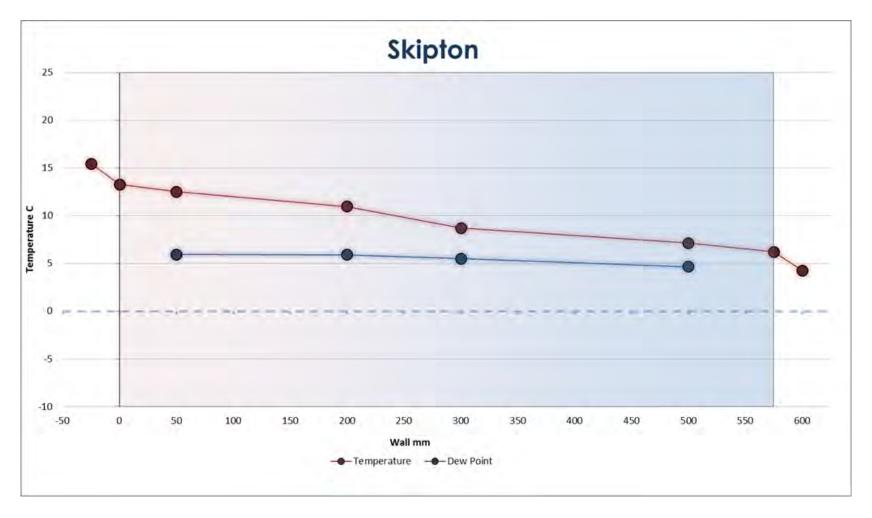
Sanstone – Hygrothermal Wall section - Static Average Pre-insulation

Rubble core - inhomogeneous wall – steeper gradient – no condensation event

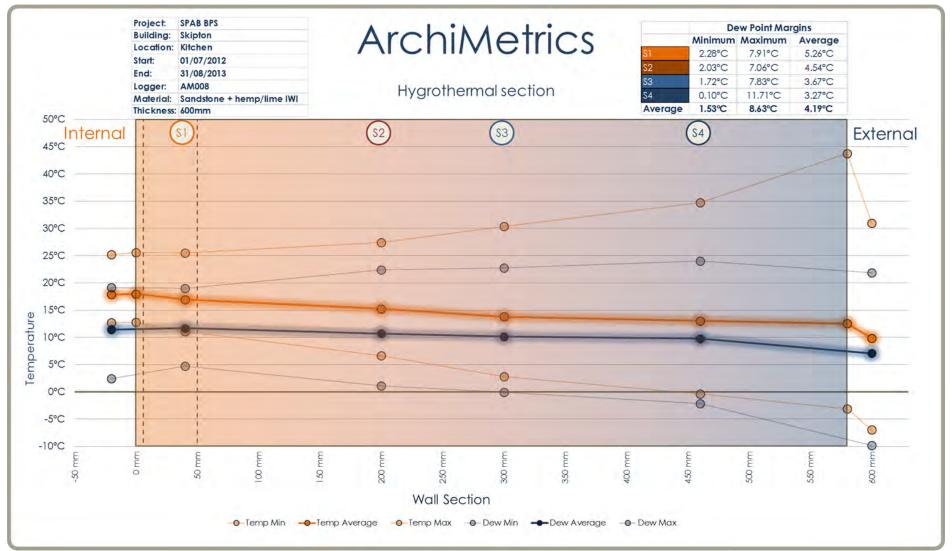
Dewpoint Margins	Feb 2011	June 2012 – Jan 2013	July 2012 – Aug 2013
Average	4.34°C	3.50°C	4.19°C
4 th Node	2.49°C	2.74°C	3.27°C

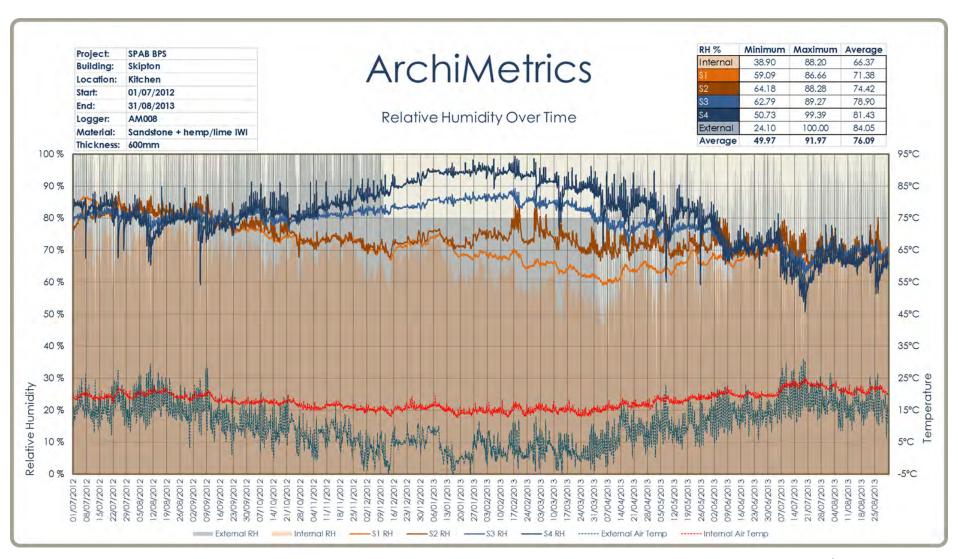
IWI – Skipton – Sandstone wall 540 mm thick insulated with 35 mm hemp/lime plaster and finished with 5mm lime plaster = 580 mm OA

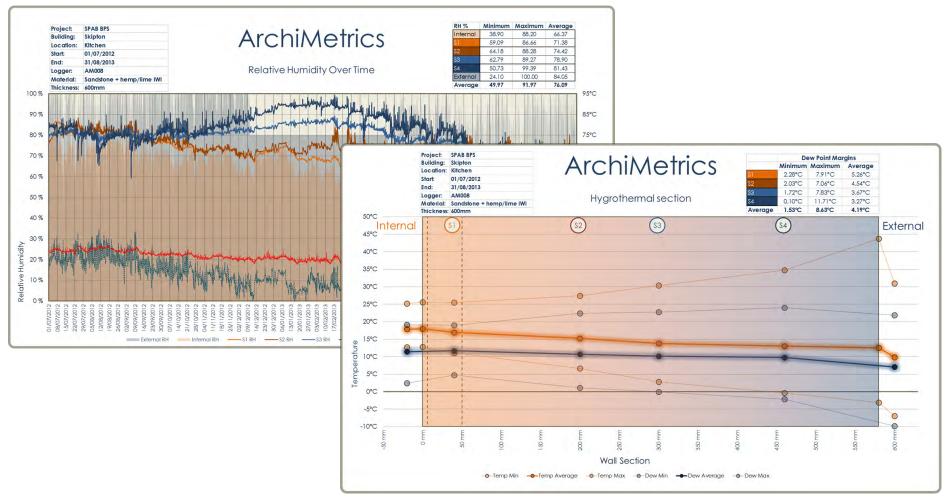
Dewpoint Margins	Average	4 th Node	In situ U-value	% reduction
Uninsulated	4.34°C	4.19°C	1.63	200/
Insulated	2.49°C	3.27°C	1.00	38%

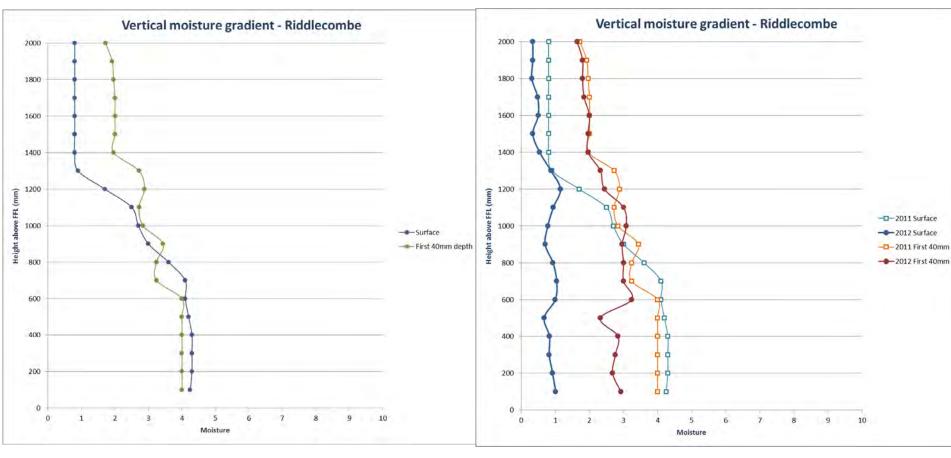
Surface & Sub surface Moisture

2011 Uninsulated

2012 Insulated

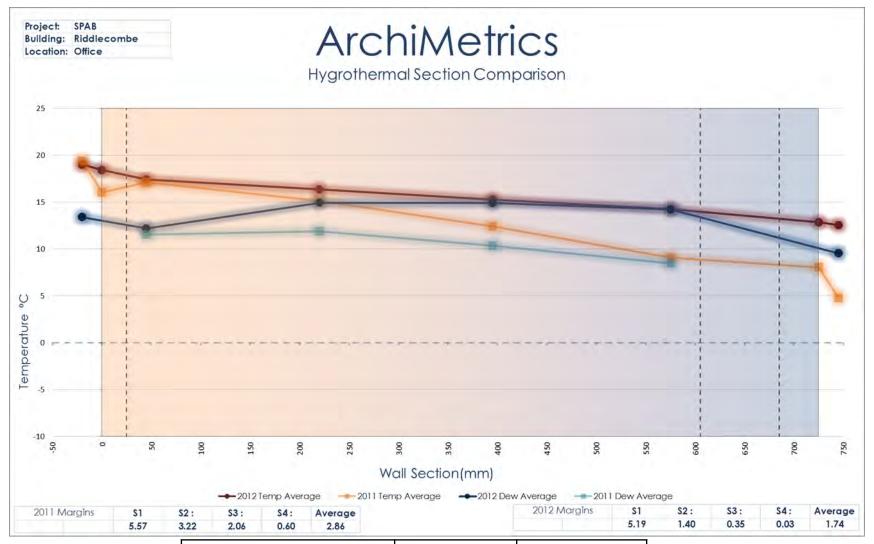
Dewpoint Margins	Average	4 th Node
Uninsulated °C	2.86°C	0.60°C
Insulated °C	1.74°C	0.03°C

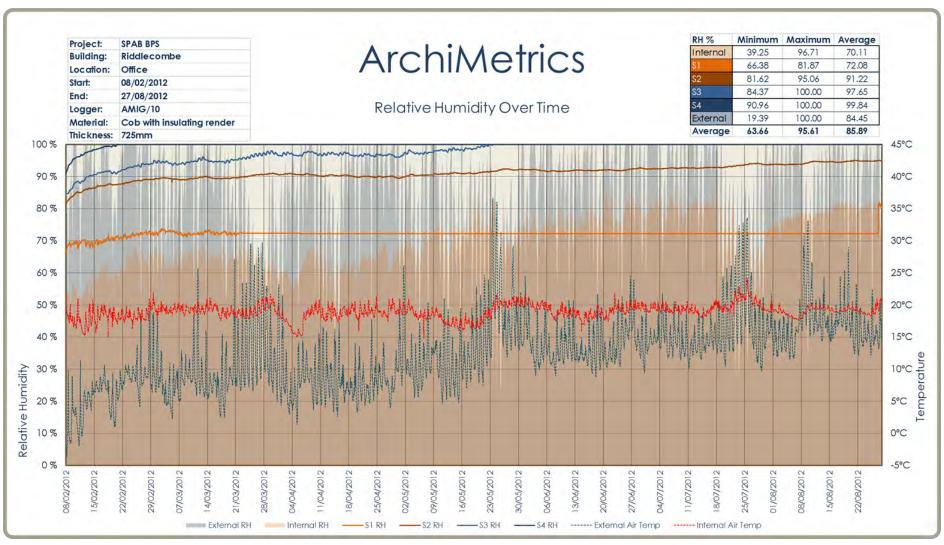
EWI – Riddlecombe – Cob wall with 50mm insulating lime render externally – lime plaster internally – 715 mm overall.

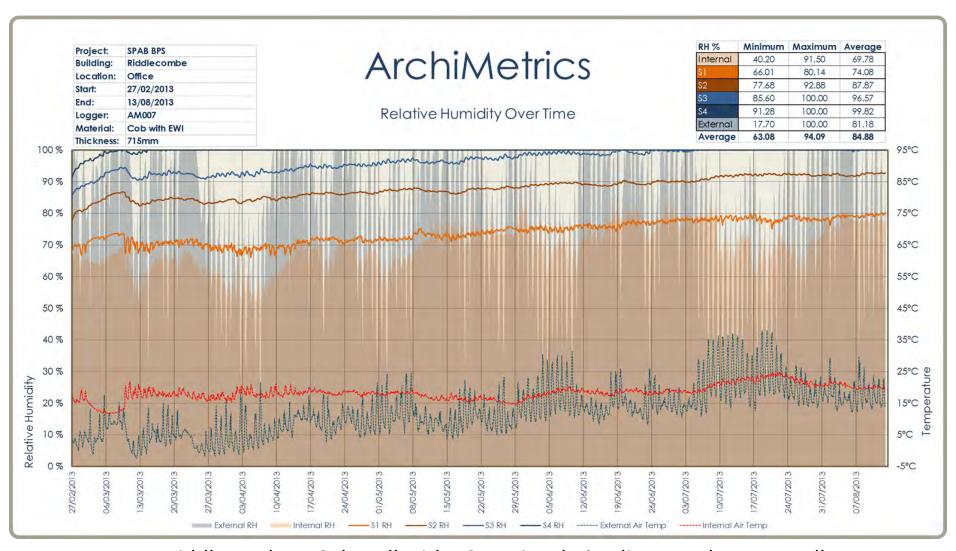
EWI – Riddlecombe – Cob wall with 50mm insulating lime render externally – lime plaster internally – 715 mm overall.

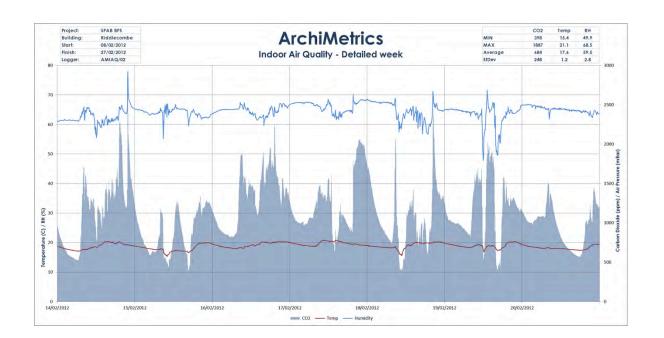
Riddlecombe CO_2 Ave = 950 ppm Max – 2824 ppm

Air Changes	Riddlecombe 2012
Air changes per hour @ 50 Pa	6.9
Air changes per hour @ ambient pressure	0.3

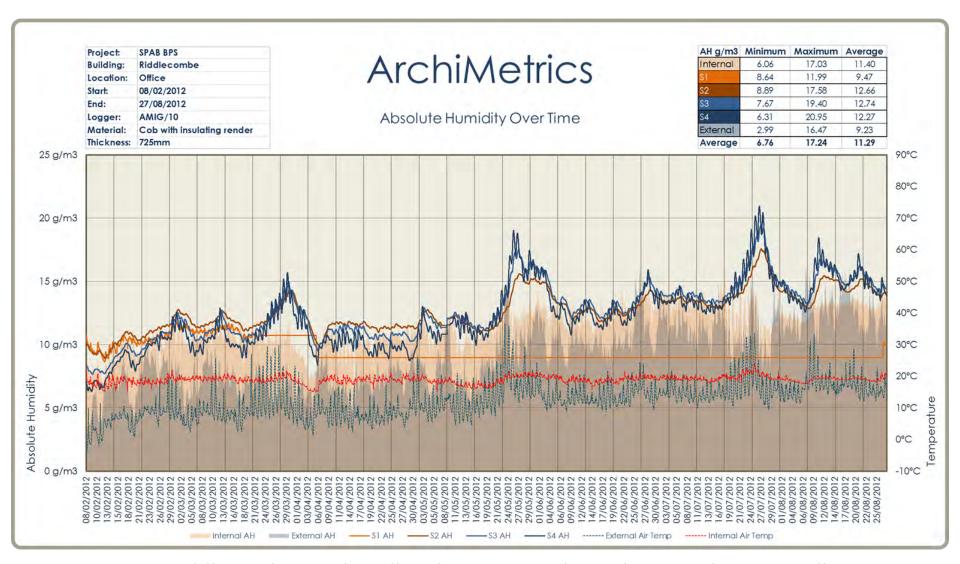
EWI – Riddlecombe – Cob wall with 50mm insulating lime render externally – lime plaster internally – 715 mm overall.

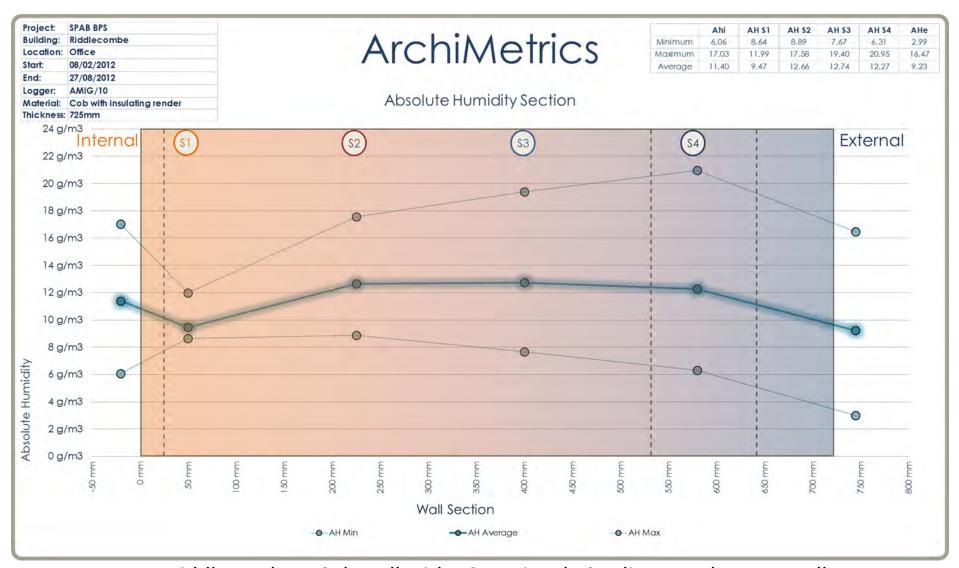
EWI – Riddlecombe – Cob wall with 50mm insulating lime render externally – lime plaster internally – 715 mm overall.

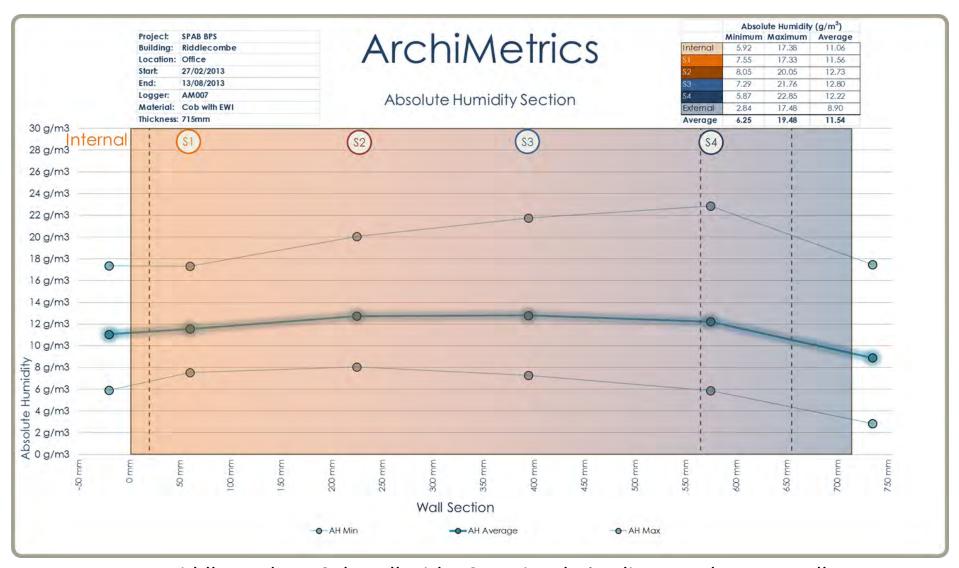
EWI – Riddlecombe – Cob wall with 50mm insulating lime render externally – lime plaster internally – 715 mm overall.

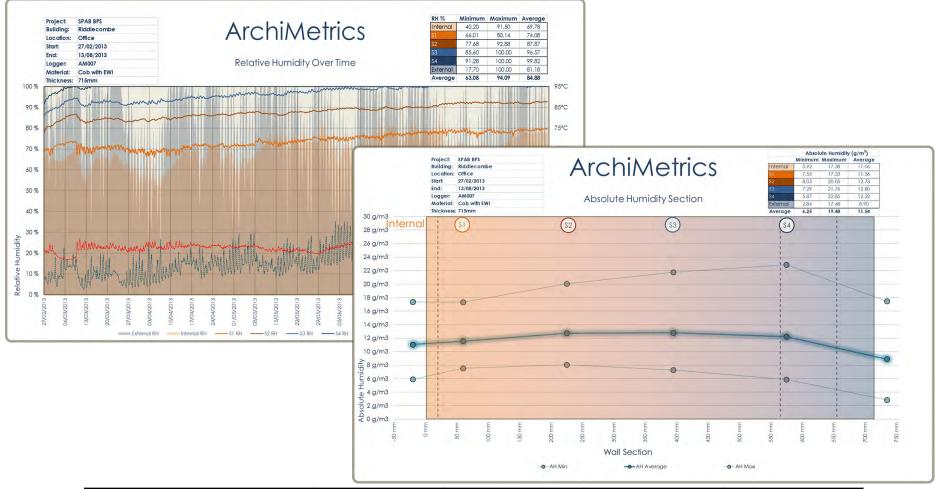
Dewpoint Margins	Average	4 th Node	In situ U- value	% reduction
Uninsulated	2.86°C	0.60°C	0.76 W/m ² K	F0/
Insulated	1.74°C	0.03°C	0.72 W/m ² K	5%

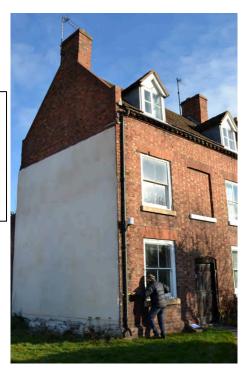
Cob wall - 725 mm - external insulating render (35mm) to replace failing existing cement render.
