Assessing the execution of retrofitted external wall insulation for pre-1919 dwellings in Swansea (UK)

The purpose of this paper is to evaluate the execution of retrofitted external wall insulation as a method of improving the thermal performance of pre-1919 dwellings with solid exterior walls. Public and private case study dwellings in Swansea, UK, have been monitored before, during and after installation of external wall insulation, which have been funded by the Welsh Government's Arbed I scheme. The installations have been procured by a principal contractor through a 'Design and Build' contract with Coastal Housing Group and Family Housing Association, based in Swansea. The methodology for the research includes field observations, to record technical solutions implemented on site, and pre-retrofit and post-retrofit thermographic surveys, to assess heat loss through the dwelling fabric. The findings include photographic, technical and thermographic evidence of potential thermal bridges, resulting from an incomplete covering of insulation. Whilst some thermal bridging is unavoidable, some could have been avoided with systematic preliminary surveys and technical detailing at the d

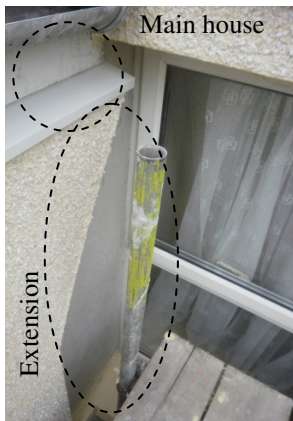
The photograph in Figure 1 was taken during the installation of the insulation at sample dwelling A. The grey area in the centre of the image has not been insulated for the reason that if it had been then the occupant would not be able to open the window. The result is a potentially large thermal bridge. This issue could have been identified in a preliminary survey and a more acceptable solution to the problem determined. Figure 1 also shows a potential thermal bridge at the eaves of the extension, which can be seen in the top left of the image, due to a capping having been installed, below the fascia board, to cover the top of the insulation. However, without extending the roof overhang, this approach to protecting the top of the insulation appears to be the only solution offered by the manufacturer.

Figure 1: Example of thermal bridging resulting from an inadequate preliminary survey

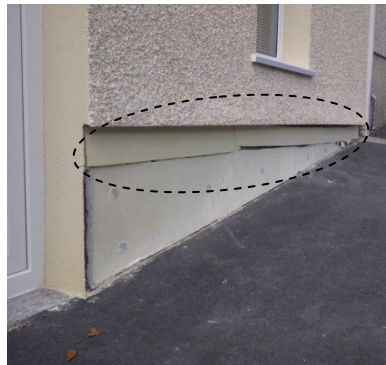
The photograph in Figure 2 was taken during the installation of the insulation at the plinth of the external wall, which joins the pavement in front of dwelling sample B. There are gaps between the insulation boards and between the insulation and the rail supporting the insulation that is covering the remainder of the wall above. These gaps appear to be due to poor workmanship on site and could lead to condensation as a result of thermal bridging. In addition, it would appear that there is sufficient door frame depth to accommodate a reduced thickness of insulation at the door reveal. However, no insulation was installed on the door reveal.

Figure 2: Example of poor execution, which could lead to thermal bridging

Insulation was not installed at the window and door reveals due to the frame thickness not being of an adequate size, despite a new door having been fitted as part of the works. However, without adjustments to the width of the opening, which could have been considered as part of a preliminary survey, a thicker door frame may have resulted in the access being below the recommended minimum width. As demonstrated in Figure 5; insulation was not installed above and below window sills. Whilst the thermal image does not show the top of the window sill, due to the angle that it was taken, there is evidence of heat escaping below the sill as a result of insulation having not been installed in this location. The heat loss between the insulation at the base of wall to that above is likely to be due to gaps created by poor execution, as demonstrated in Figure 2

above. However, it should be noted that Figures 2 and 9 are different dwellings. Whilst overall heat loss appears to have been reduced, there is evidence of thermal bridging due to an incomplete covering of insulation and poor execution on site. Together, Figures 2, 3 and 10 could be used as part of training material for external wall insulation installers to provide a visual method of illustrating the consequences of poor execution on site.

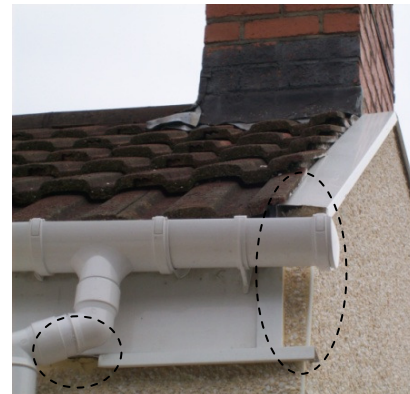
The photograph in Figure 3 was taken after the installation of insulation at dwelling sample C and shows the eaves and gable wall junction of an end-terrace dwelling. The new fascia board stops short of the end of the external wall. As a result, a small area of insulation, which had not been covered by the fascia board, had to be rendered and a dash finish applied. In addition, the overhang of the capping had to be cut away to allow the new rainwater downpipe to be fitted and thus poses a risk of insufficient protection to the top of the insulation. Had an adequate preliminary survey been undertaken, there could have been appropriate detailing at the design stage and then this could have been executed on site.

Figure 3: Example of poor detailing and execution resulting from an inadequate preliminary survey

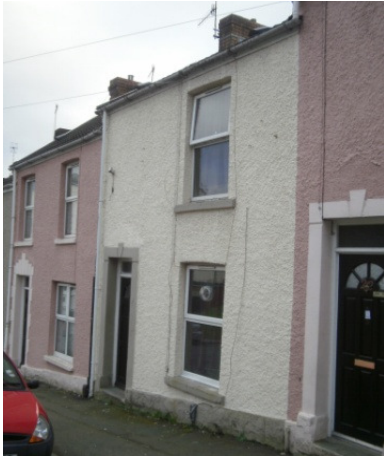
Within the thermal images, the lighter shades represent the greatest amount of heat loss and the darker shades, the least. *Please note: the temperature scale on the thermal images is not representative of actual temperature readings as these are qualitative survey images.* Figures 6 and 7 show dwelling sample D before the external wall insulation system was installed.

Figure 6: Photograph of dwelling before installation of insulation

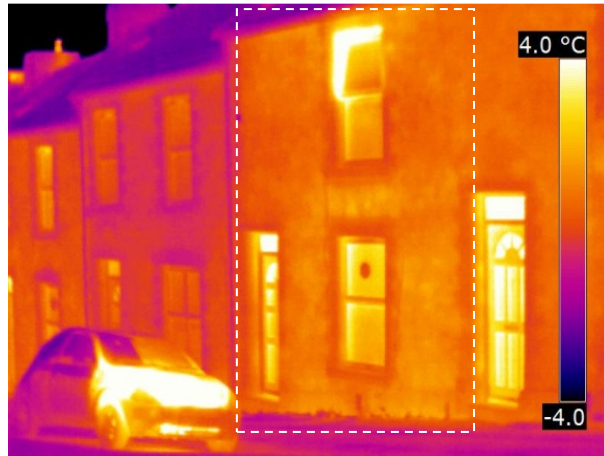
Figure 7: Pre-R:T survey image of dwelling, as shown in Figure 6

The apparent increased heat loss from the ground floor external wall to that for the first floor could be a result of the first floor rooms being cooler due to the window being open. Figures 8 to 10 show the same dwelling sample D, after the insulation was installed. Figure 10 does not illustrate the whole dwelling; it is just a focus on the bottom of the external wall. There appears to be evidence of thermal bridging: at the step below the external door; at window and door reveals; under the window sill; and where the insulation used at the base of the wall joins that used for the remainder of the wall above. Overcoming the potential thermal bridge at the step and below the exterior door is a junction where a solution does not appear to have been explored; this is evidenced by the lack of information available within the manufacturer's documentation, for example BBA certificate number: 03/4058 (BBA, 2011).

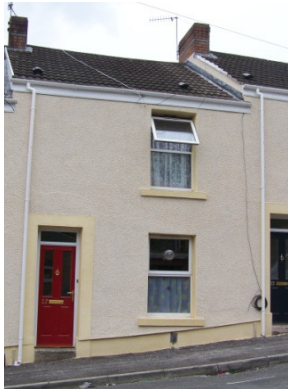
Figure 8: Photograph of dwelling shown in Figure 6, after installation of insulation

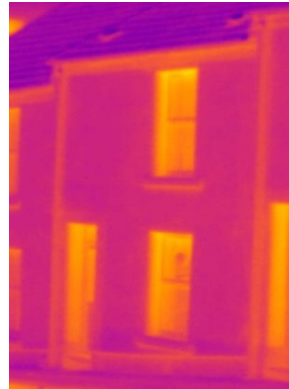
Figure 9: Post-R:T survey image of dwellings, as shown in Figure 8
