Solid wall insulation installers: knowledge, motivation and the role of policy

Tim Forman, PhD Researcher
Welsh School of Architecture, Cardiff University

Wall insulation: getting it right in old buildings

Wales Traditional & Sustainability Building Skills Advisory Group
25 March, 2014

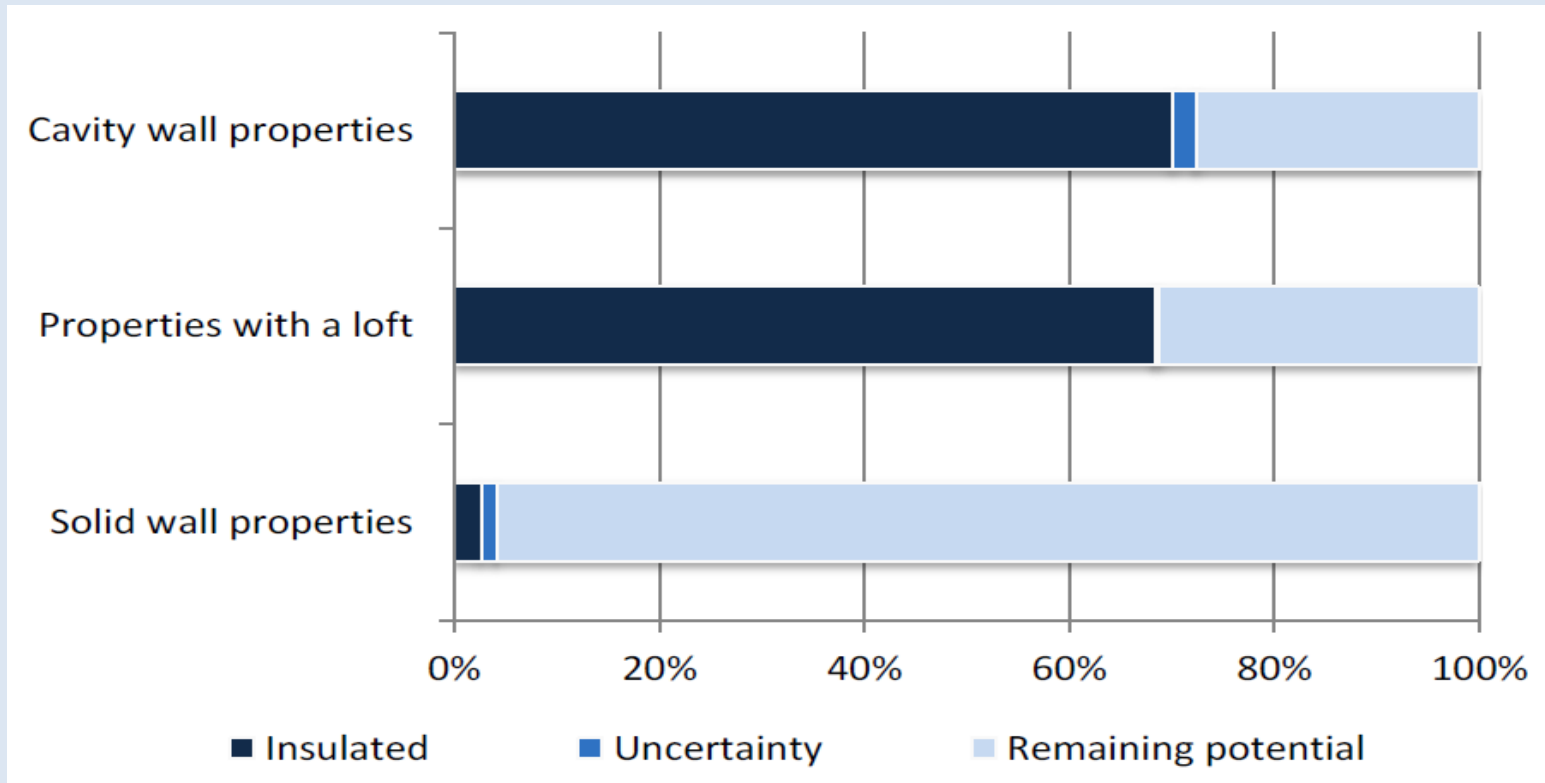
Remaining potential to insulate UK housing stock (July 2013) (DECC, 2013)

- ~7.7m solid wall + ~4.5m hard-to-treat cavity properties without insulation
- Rise in installations:
 - +31% (36,000) Oct 2011 - Oct 2012
 - +45% (65,000) Jul 2012 - Jul 2013

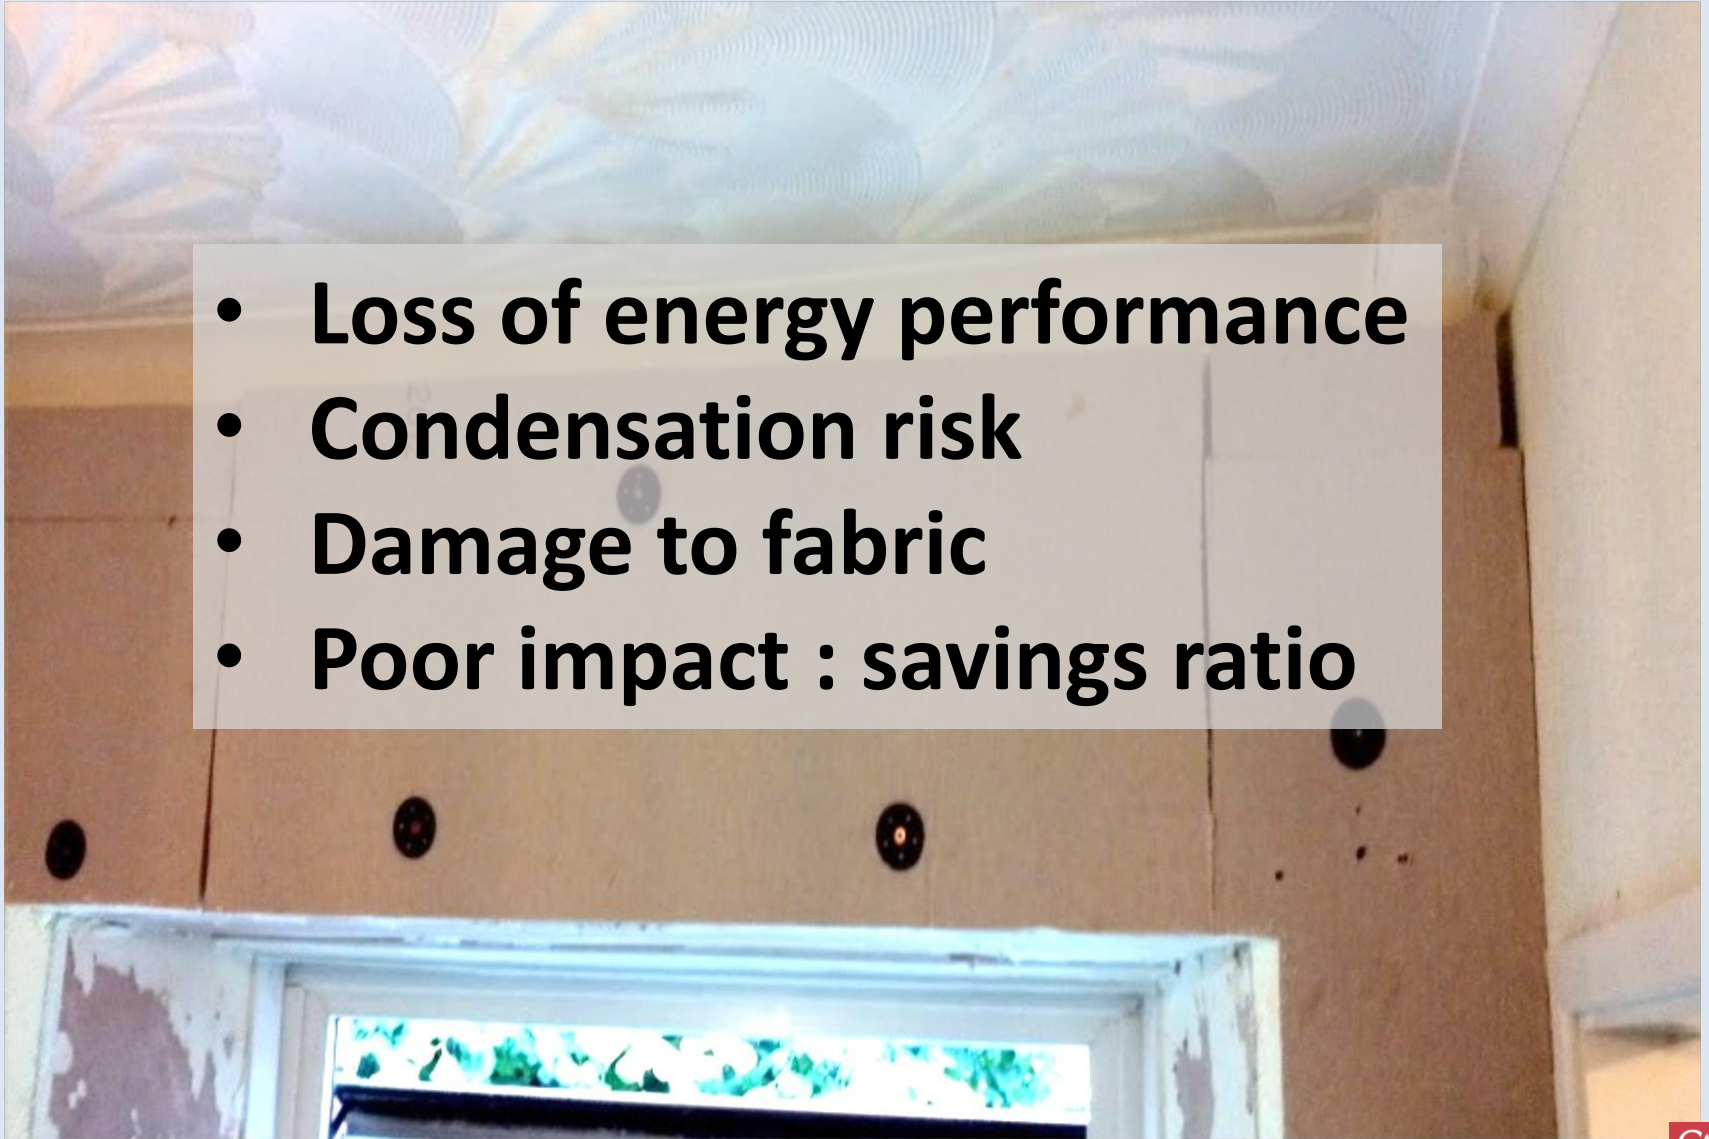
Skill, understanding and motivation

- **Loss of energy performance**
- **Condensation risk**
- **Damage to fabric**
- **Poor impact : savings ratio**
